Merrifield Estate - Stage 42, Mickleham

Level 1 Inspection & Testing Report

Reference: 1120 0283-1

BMD Urban

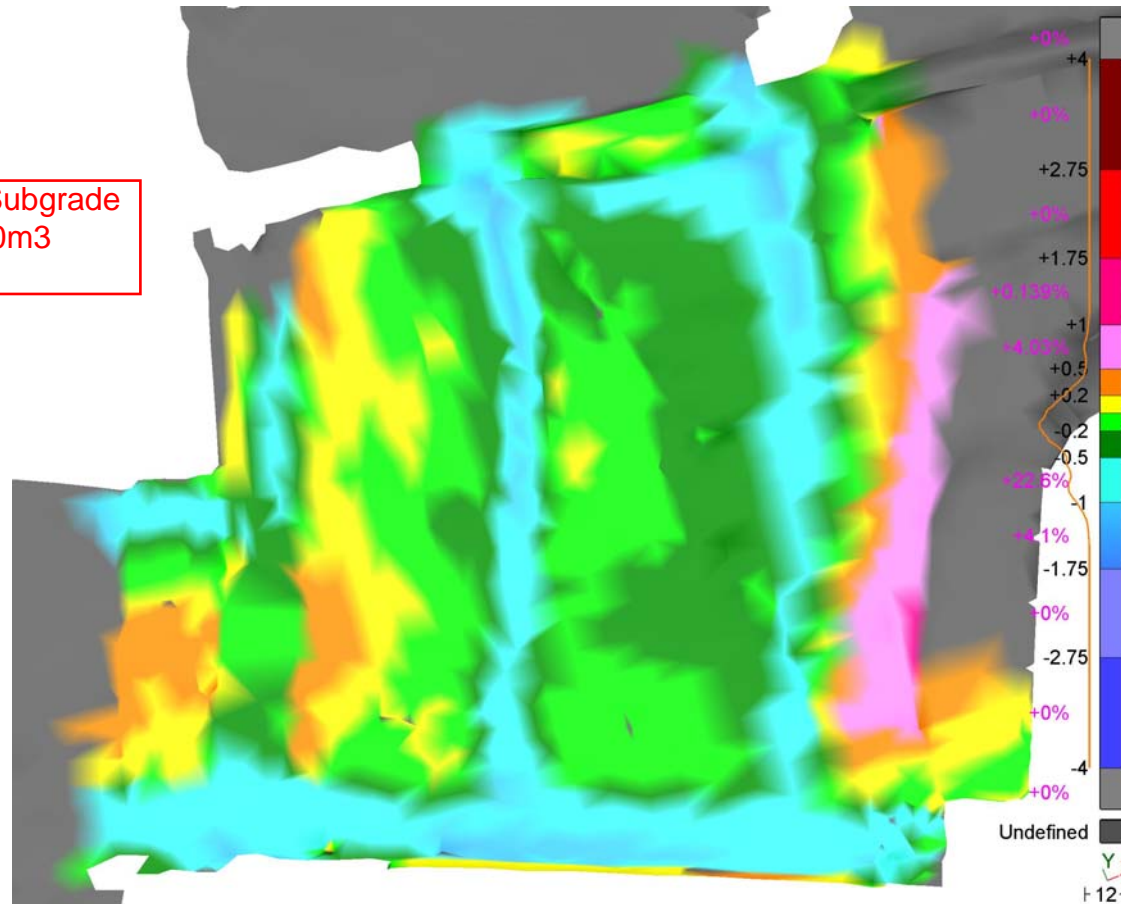
Merrifield St42 Heatmap

Supplied Strip vs Subgrade
Fill Placed - 2,540m³
Cut - 13,670m³
