# **Merrifield Estate - Stage 43, Mickleham**

## **Level 1 Inspection & Testing Report**

Reference: 1120 0316-1

BMD Urban

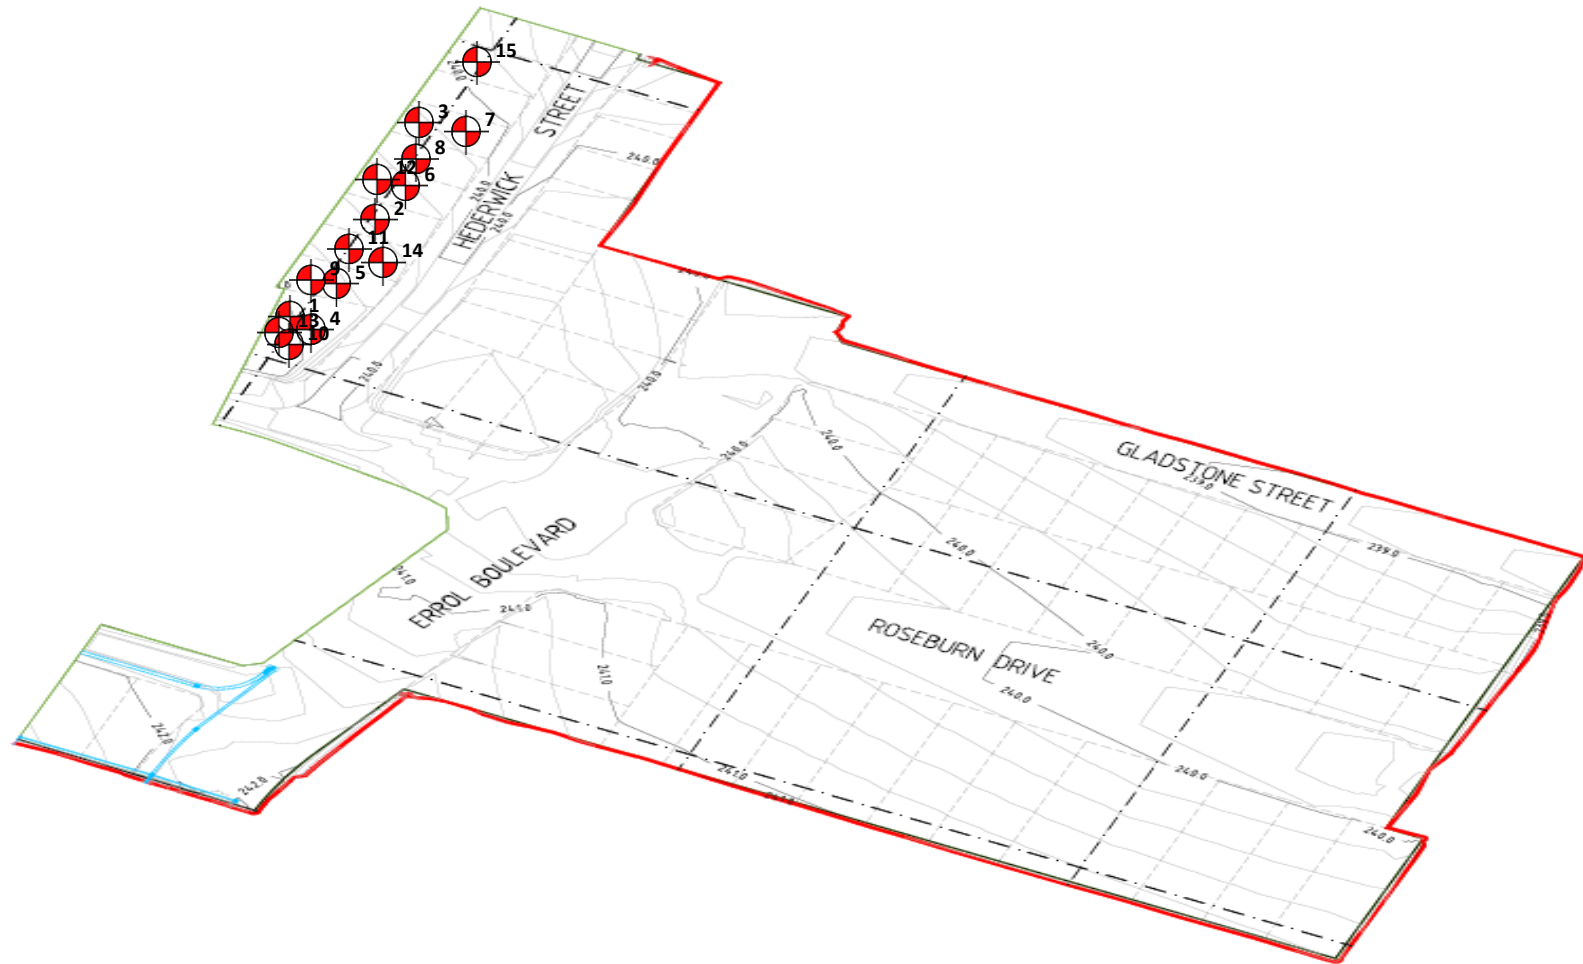
## **Appendix B – Test Locations**

The locations of the 15 field density tests are shown in Appendix B – Test Locations. A summary of the test results obtained from the field density testing is presented in Appendix C – Test Results Summary. The laboratory test reports of the field density tests are presented in Appendix D – NATA Test Results.
