Merrifield Estate - Stage 44, Mickleham

Level 1 Inspection & Testing Report

Reference: 1120 0313-1

BMD Urban

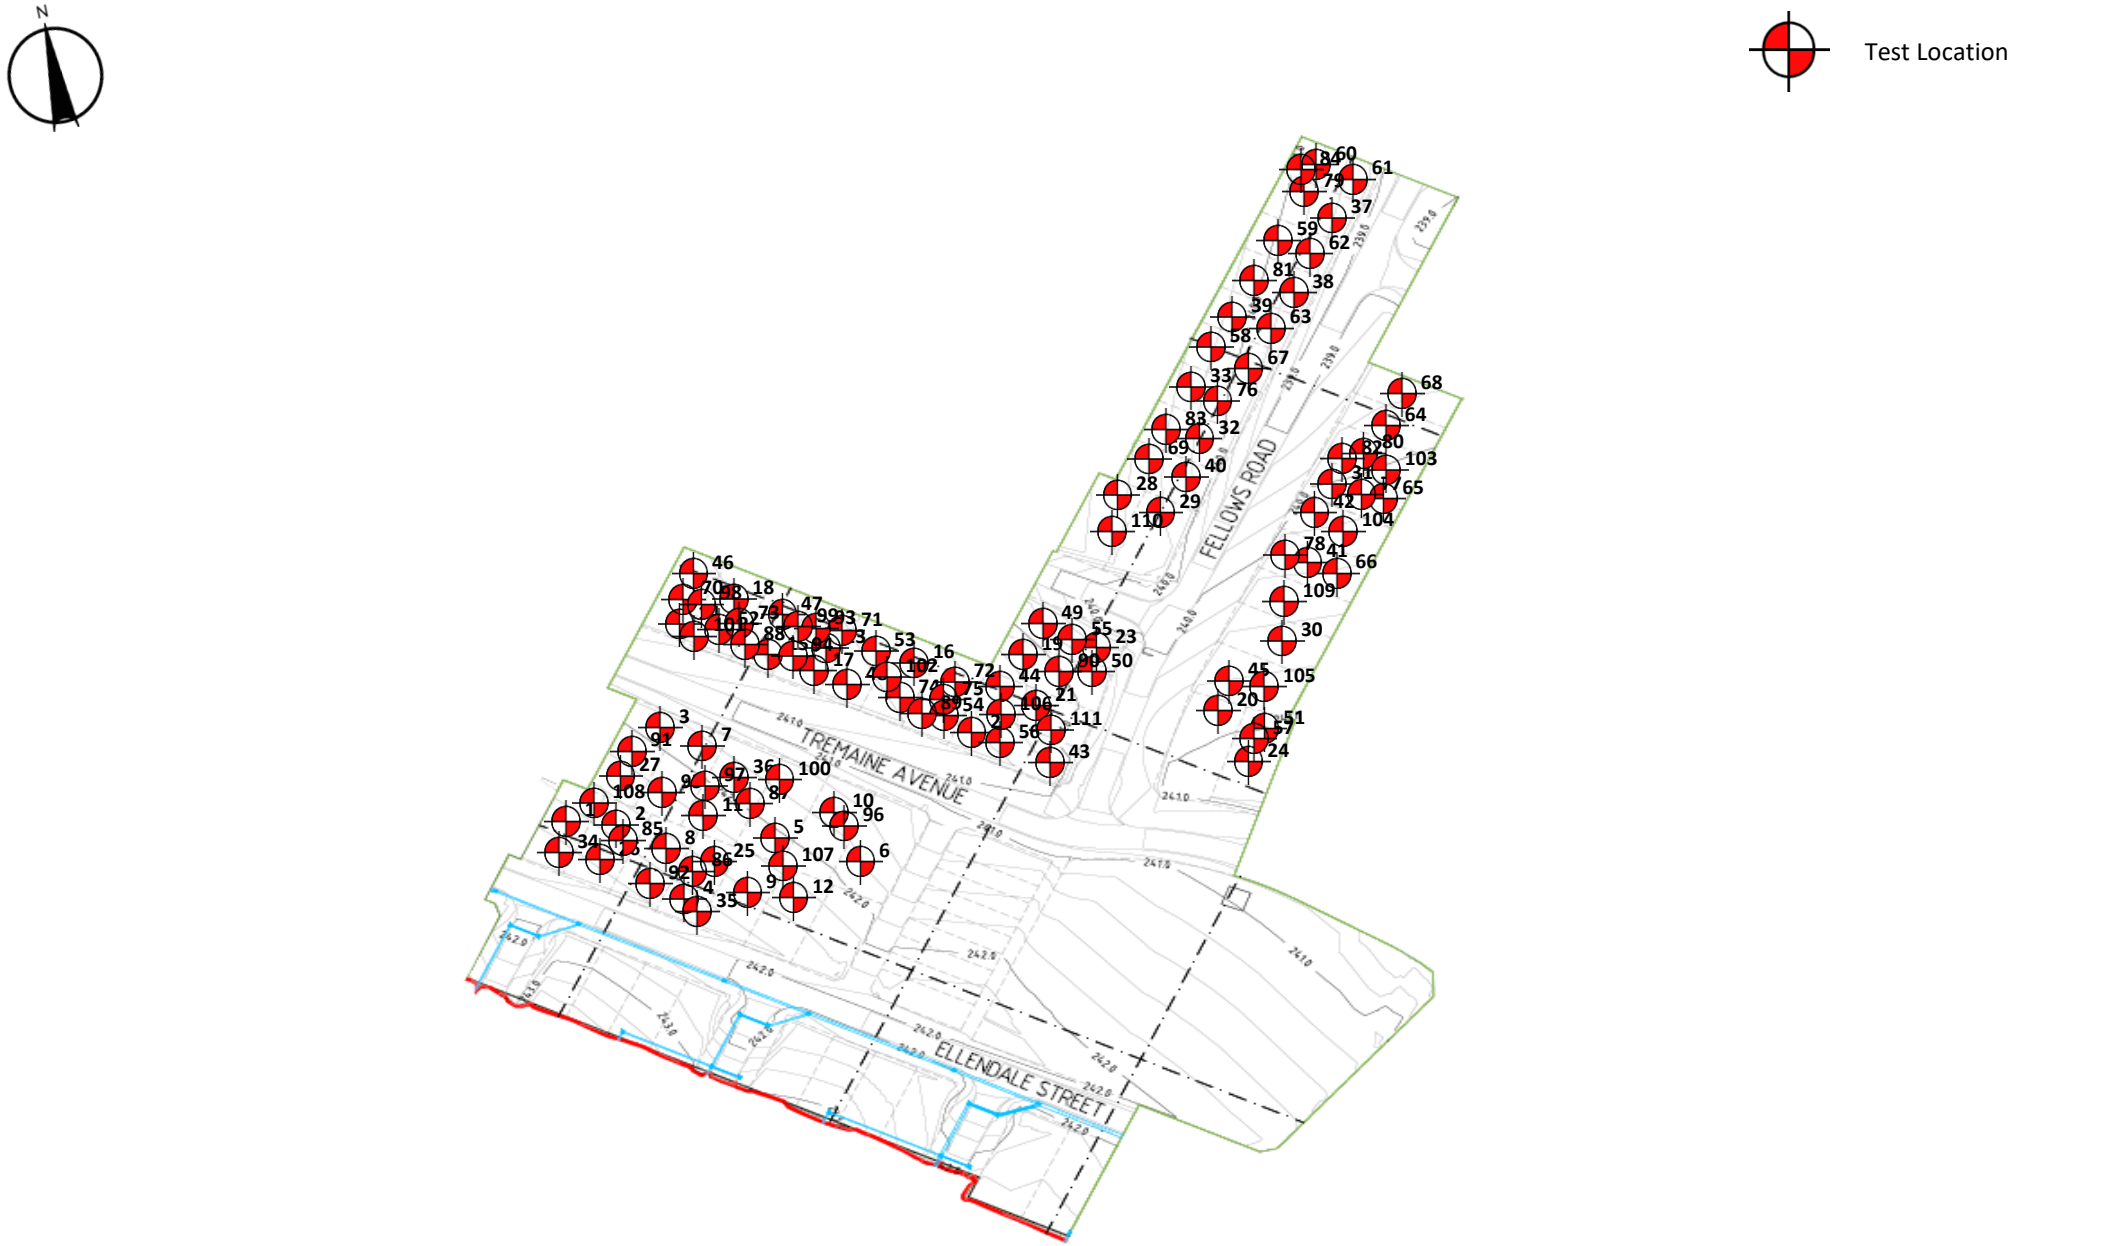
Appendix B – Test Locations

The locations of the 111 field density tests are shown in Appendix B – Test Locations. A summary of the test results obtained from the field density testing is presented in Appendix C – Test Results Summary. The laboratory test reports of the field density tests are presented in Appendix D – NATA Test Results.
