Merrifield Estate - Stage 47, Mickleham

Level 1 Inspection & Testing Report

Reference: 1120 0304-1

BMD Urban

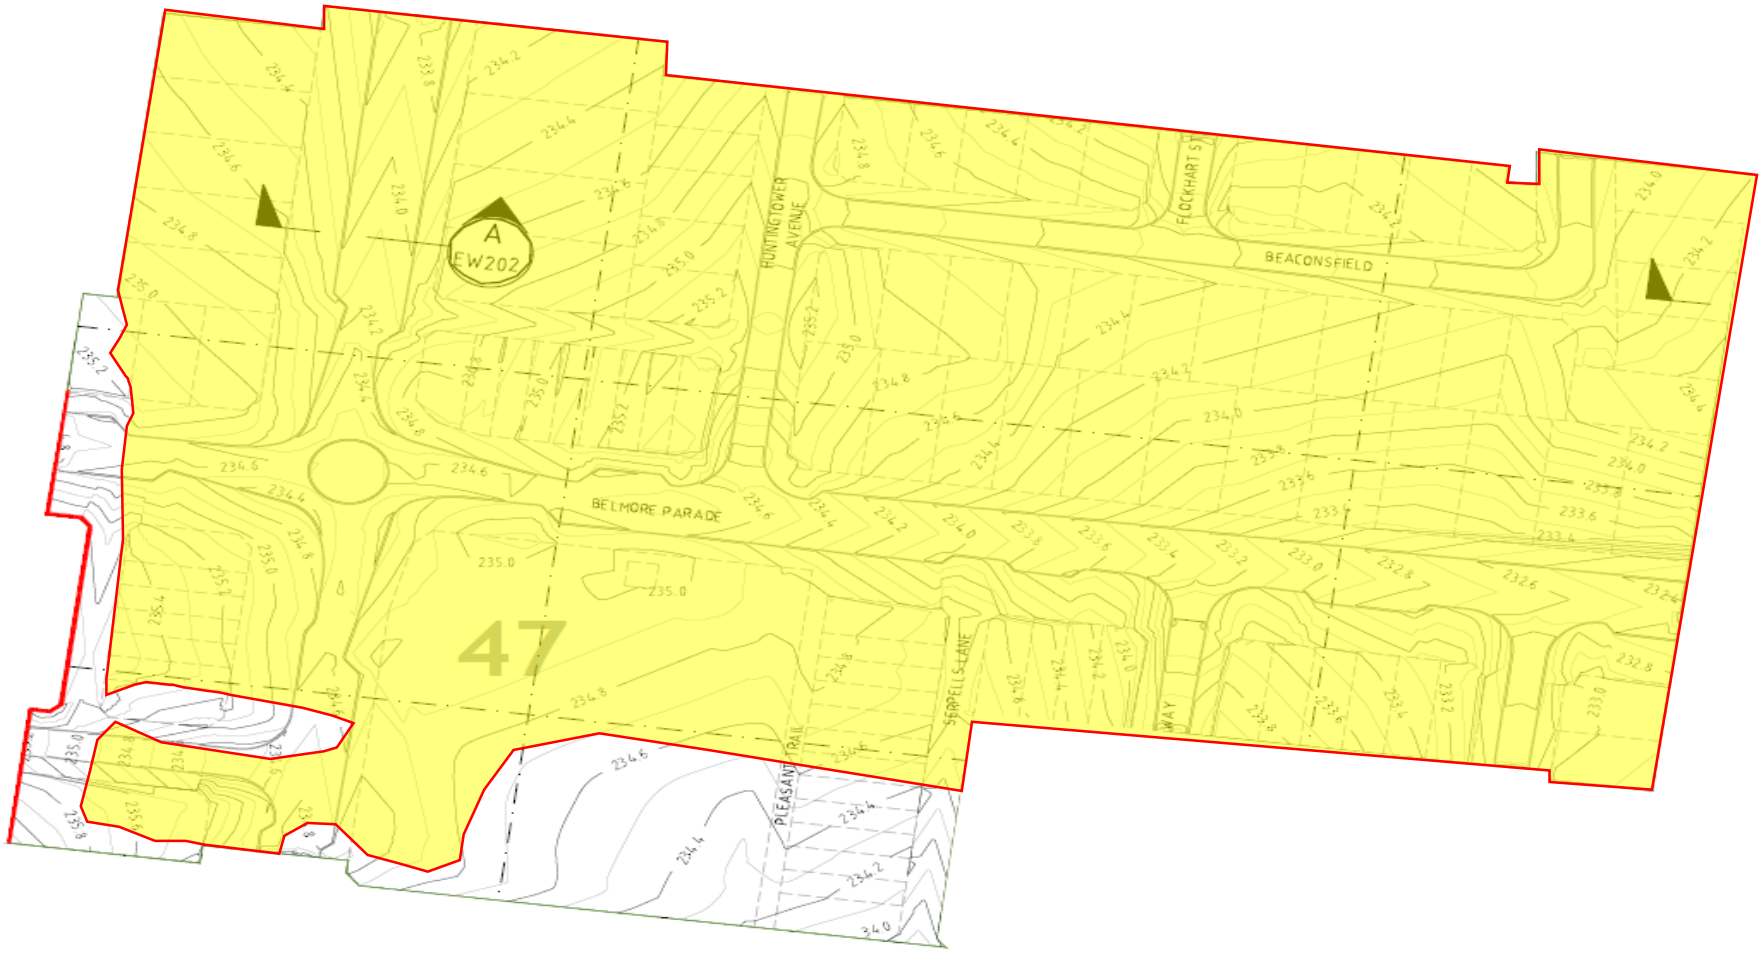
Area Inspected and Tested

This report is applicable for fill placed by BMD Urban in Merrifield Estate - Stage 47, Mickleham, as shown in Appendix A – Site Plan.

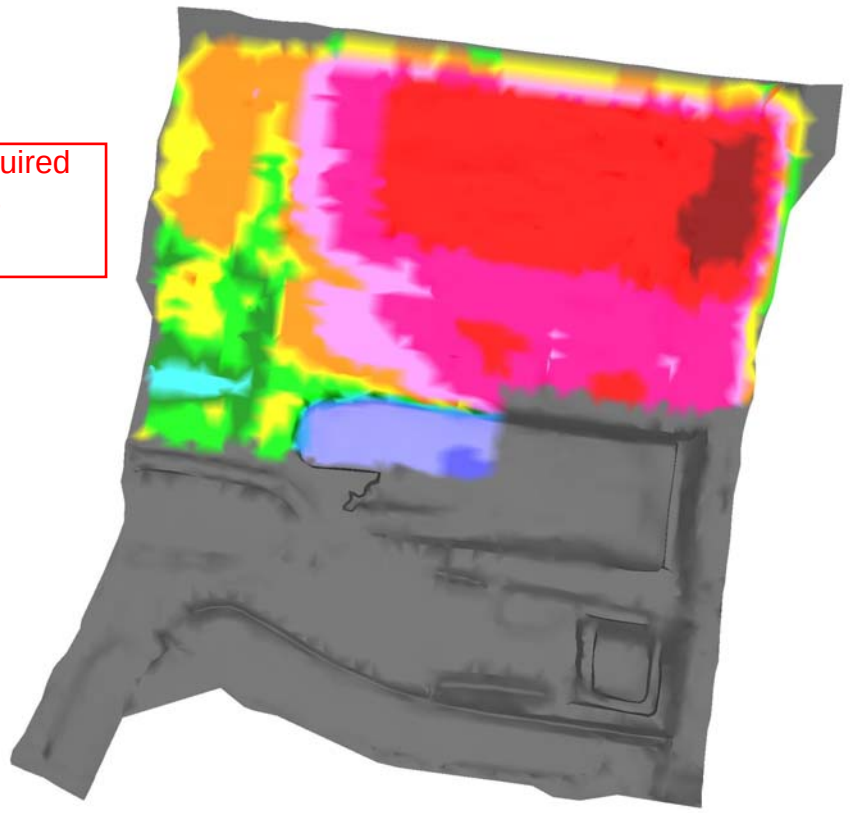
3D view hardcopy

A heat map indicating the amount of cut and fill prepared by JAC Surveyors dated 10th March 2022 has been attached in Appendix A along with the site plan. It should be noted that the level 1 inspection and testing also cover some areas in the cut zone due to soft spot remediation and over-excavation during the removal of stockpiles placed on site.

Volumes Required
Fill-84,670m3
Cut-8,860m3
