# **Merrifield Estate - Stage 53, Mickleham**

## **Level 1 Inspection & Testing Report**

Reference: 1120 0370-1

BMD Urban

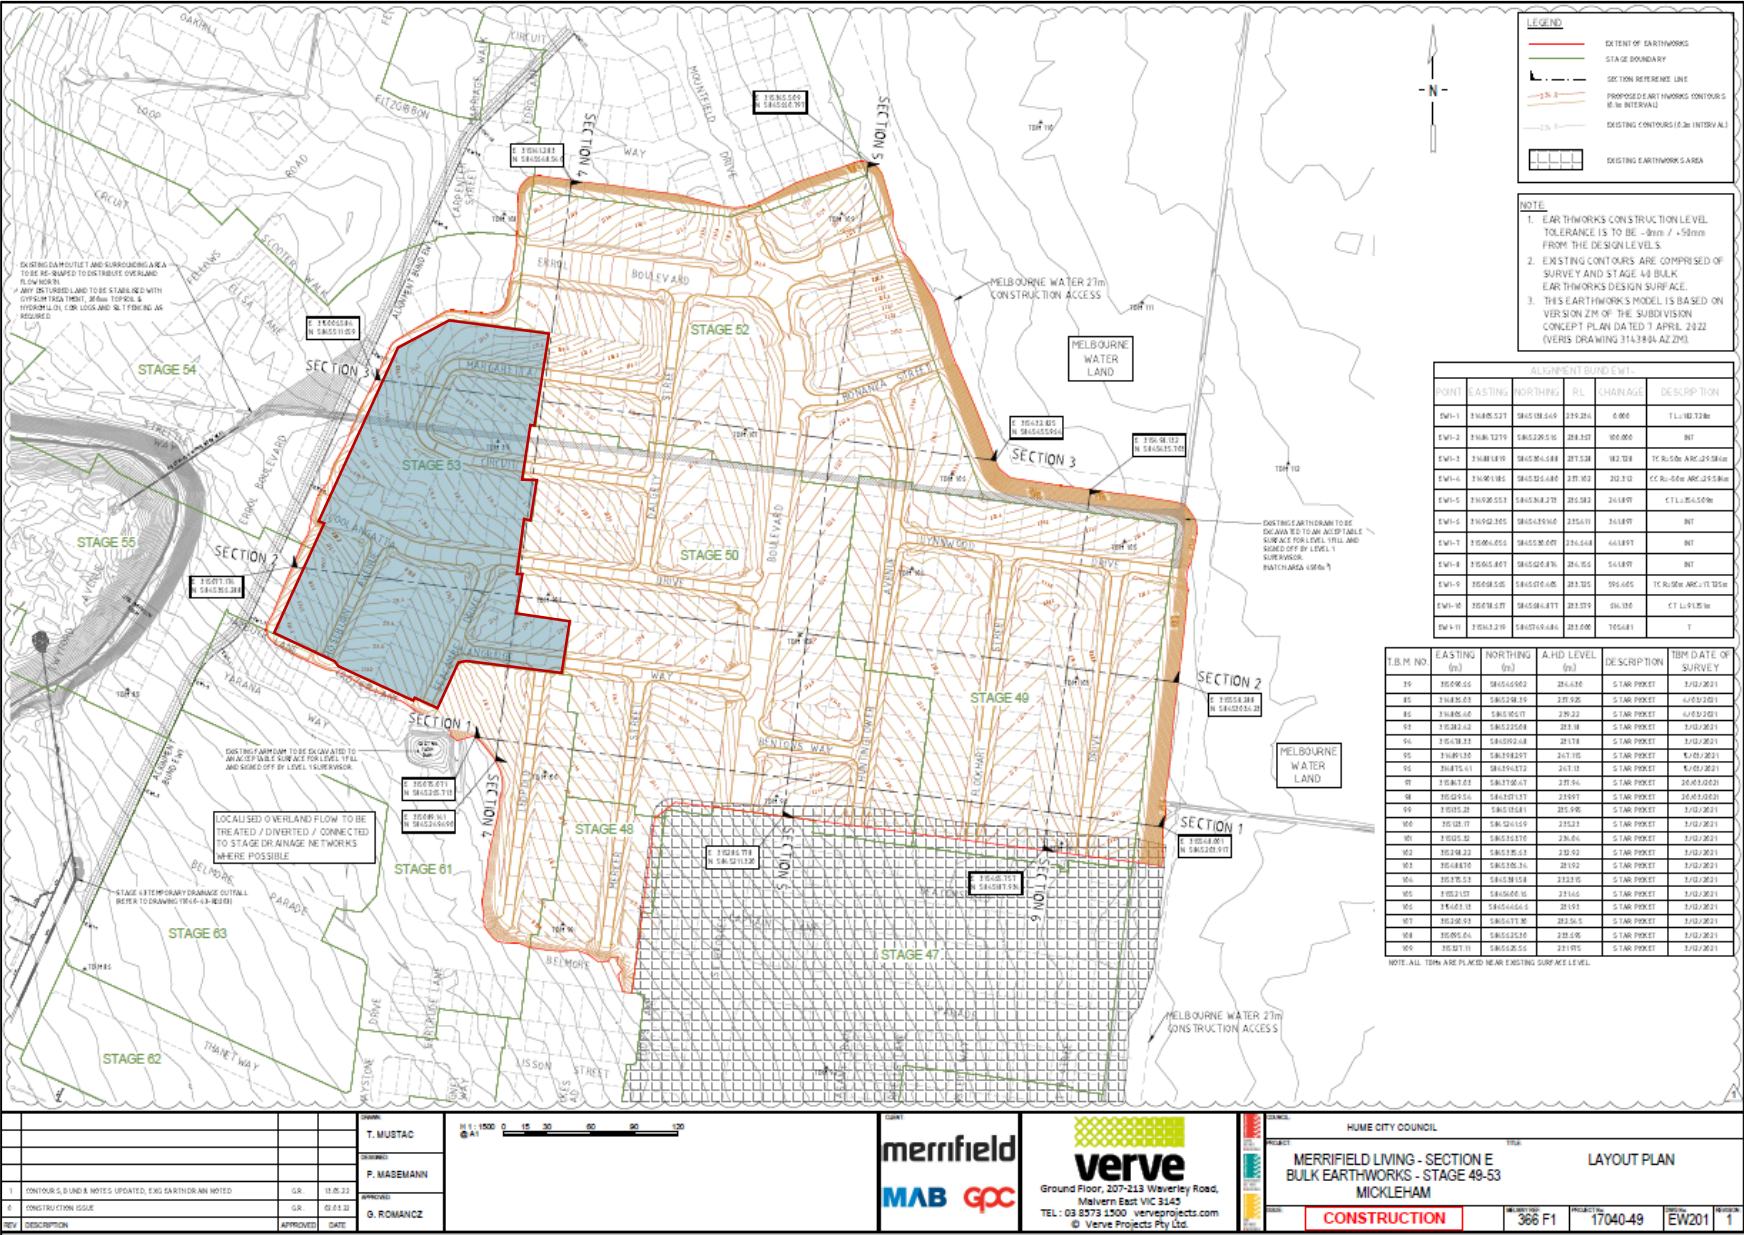
Area Inspected  
and Tested

**PROJECT:**  
Merrifield Estate – Stage 53 (Level 1)

**LOCATION:**  
Mickleham

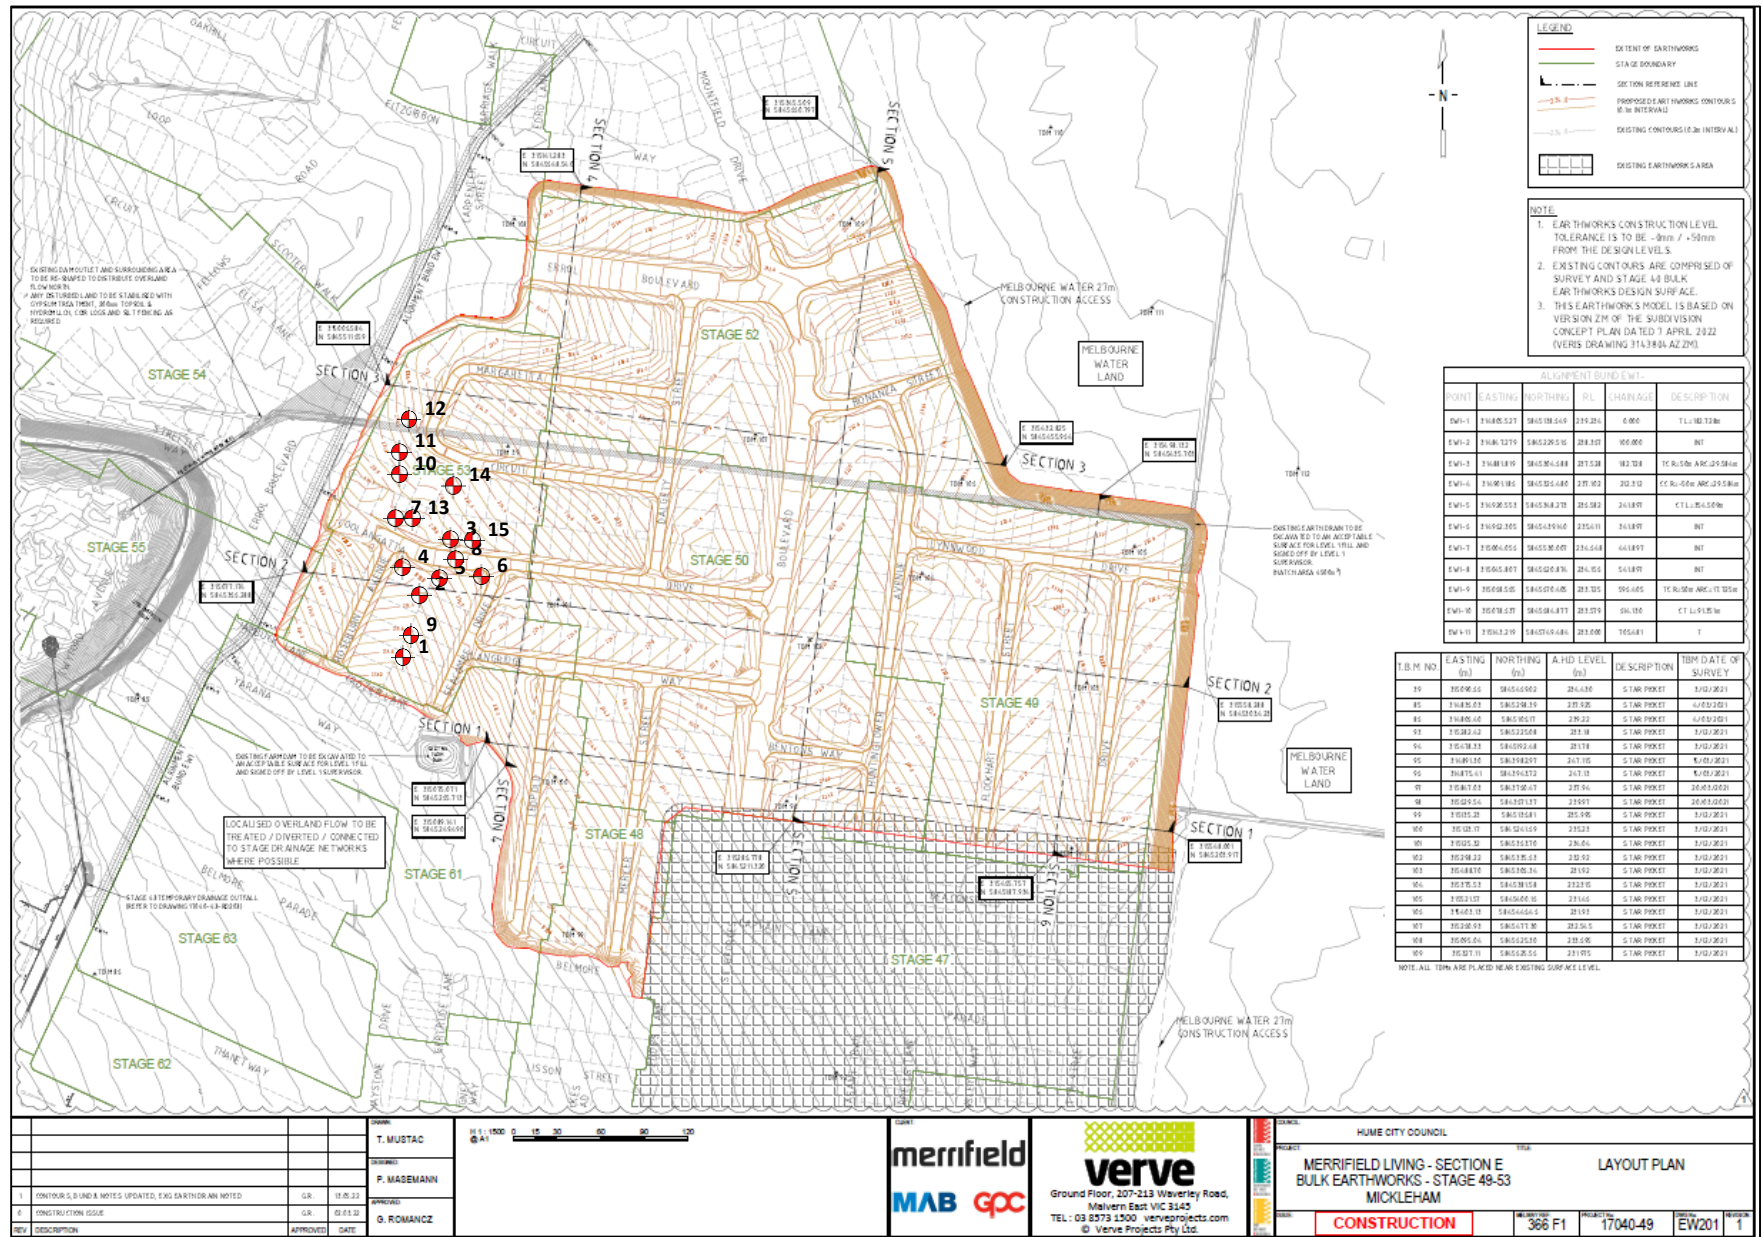
## **Appendix B – Test Locations**

**PROJECT:**  
Merrifield Estate - Stage 53 (Level1)

**LOCATION:**  
Mickleham

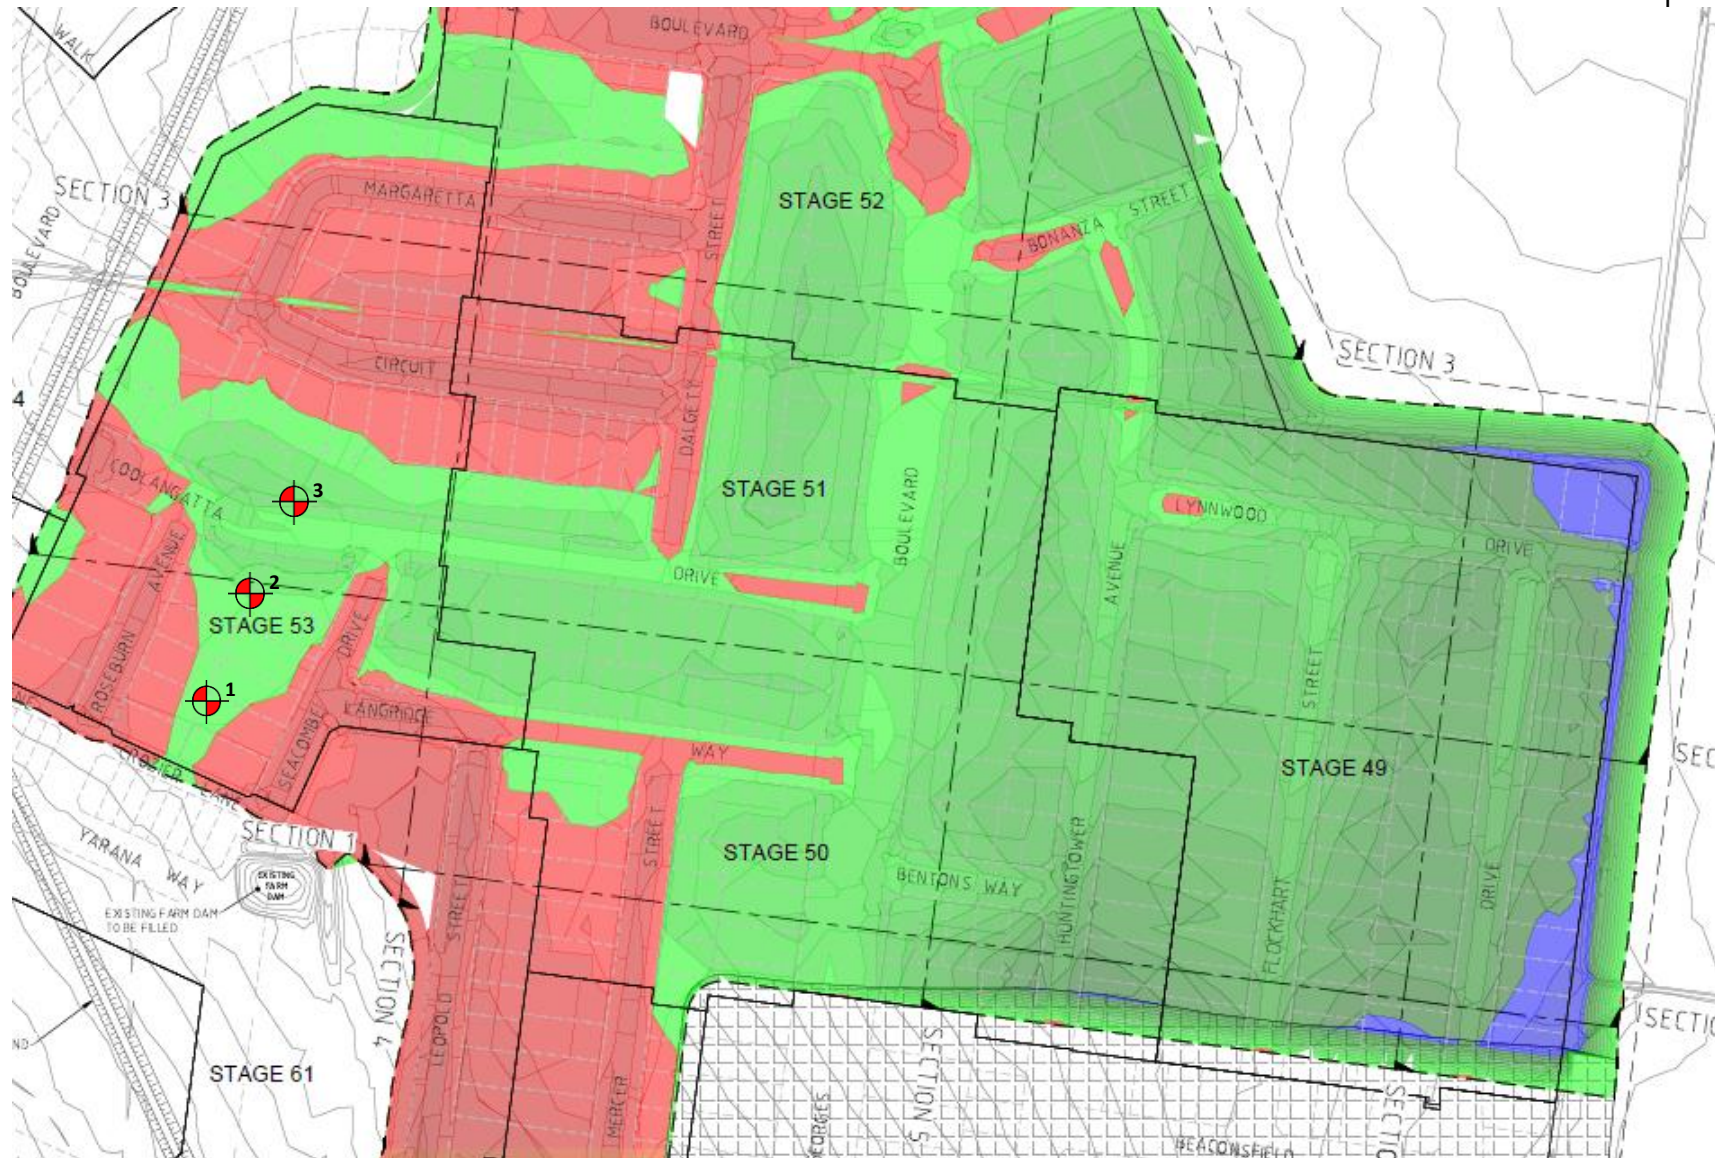
PROJECT: Merrifield Estate – Stage 53 (Level 1)	CLIENT: BMD Urban	DATE: 04/10/2022

Test Location	Refer to Plan	Refer to Plan	Refer to Plan			
Level/Layer	1	1	1			
Layer Thickness	mm 200	mm 200	mm 200			
Test Depth	mm 175	mm 175	mm 175			
Field Wet Density	t/m <sup>3</sup> 1.86	t/m <sup>3</sup> 1.83	t/m <sup>3</sup> 1.84			
Field Moisture Content	% 23.2	% 24.6	% 24.3			
Material:	Imported Clay	Imported Clay	Imported Clay

Oversize Material	WET, % 0.0	WET, % 0.0	WET, % 0.0			
Sieve Size	mm 19	mm 19	mm 19			
Peak Converted Wet Density	t/m <sup>3</sup> 1.89	t/m <sup>3</sup> 1.87	t/m <sup>3</sup> 1.86			
Optimum Moisture Content	% 24	% 22.5	% 24.5

<b>Moisture Ratio</b>	% 96.5	% 109.5	% 99			
<b>Moisture Variation</b>	% -0.5	% 2.0	% -0.5			
<b>from OMC</b>	Drier	Wetter	Drier			
<b>Density Ratio</b>	% 98.5	% 98.0	% 98.5

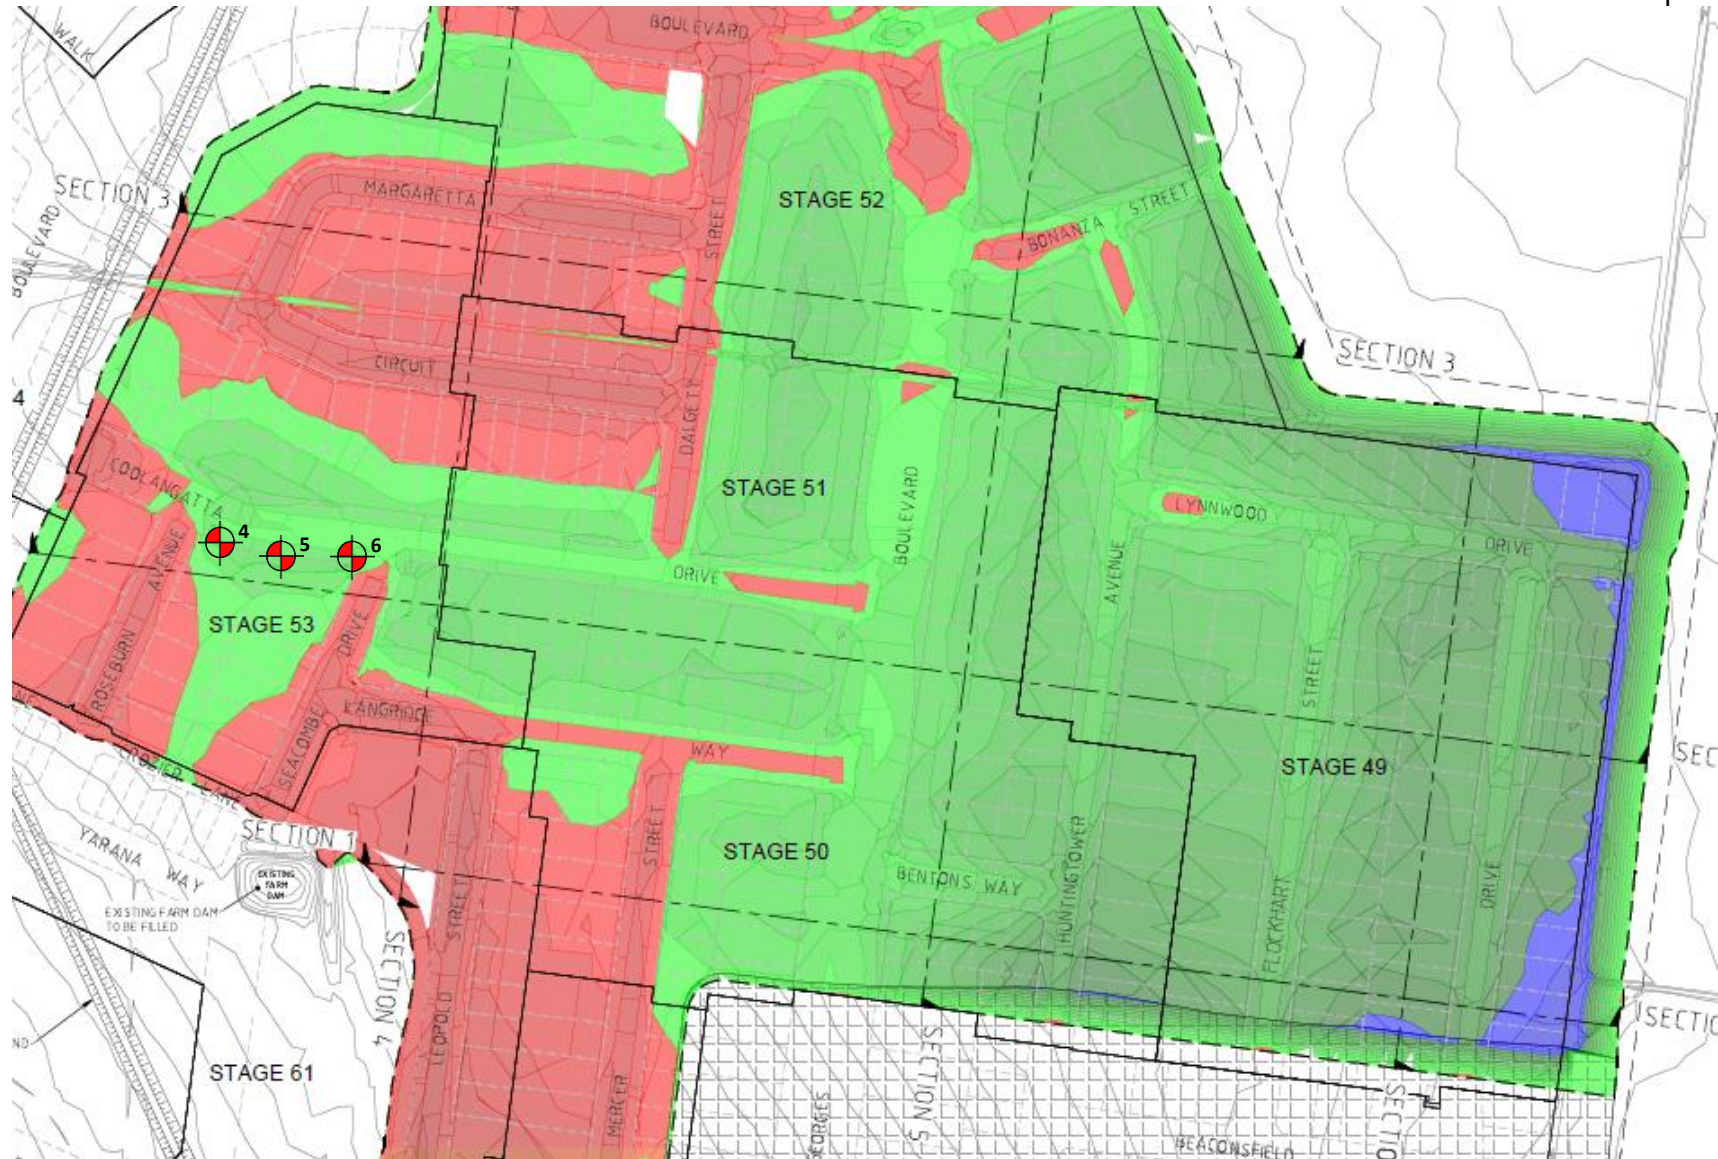
PROJECT: Merrifield Estate – Stage 53 (Level 1)	CLIENT: BMD Urban	DATE: 05/10/2022

Test Location	Refer to Plan	Refer to Plan	Refer to Plan			
Level/Layer	2	2	2			
Layer Thickness	mm 200	mm 200	mm 200			
Test Depth	mm 175	mm 175	mm 175			
Field Wet Density	t/m <sup>3</sup> 1.80	t/m <sup>3</sup> 1.83	t/m <sup>3</sup> 1.86			
Field Moisture Content	% 23.1	% 23.9	% 24.6			
Material:	Imported Clay Fill	Imported Clay Fill	Imported Clay Fill

Oversize Material	WET, % 0.0	WET, % 0.0	WET, % 0.0			
Sieve Size	mm 19	mm 19	mm 19			
Peak Converted Wet Density	t/m <sup>3</sup> 1.83	t/m <sup>3</sup> 1.86	t/m <sup>3</sup> 1.90			
Optimum Moisture Content	% 24	% 24	% 23

<b>Moisture Ratio</b>	% 96.5	% 99.5	% 107			
<b>Moisture Variation</b>	% -0.5	% -0.5	% 1.5			
<b>from OMC</b>	Drier	Drier	Wetter			
<b>Density Ratio</b>	% 98.5	% 98.5	% 98.0

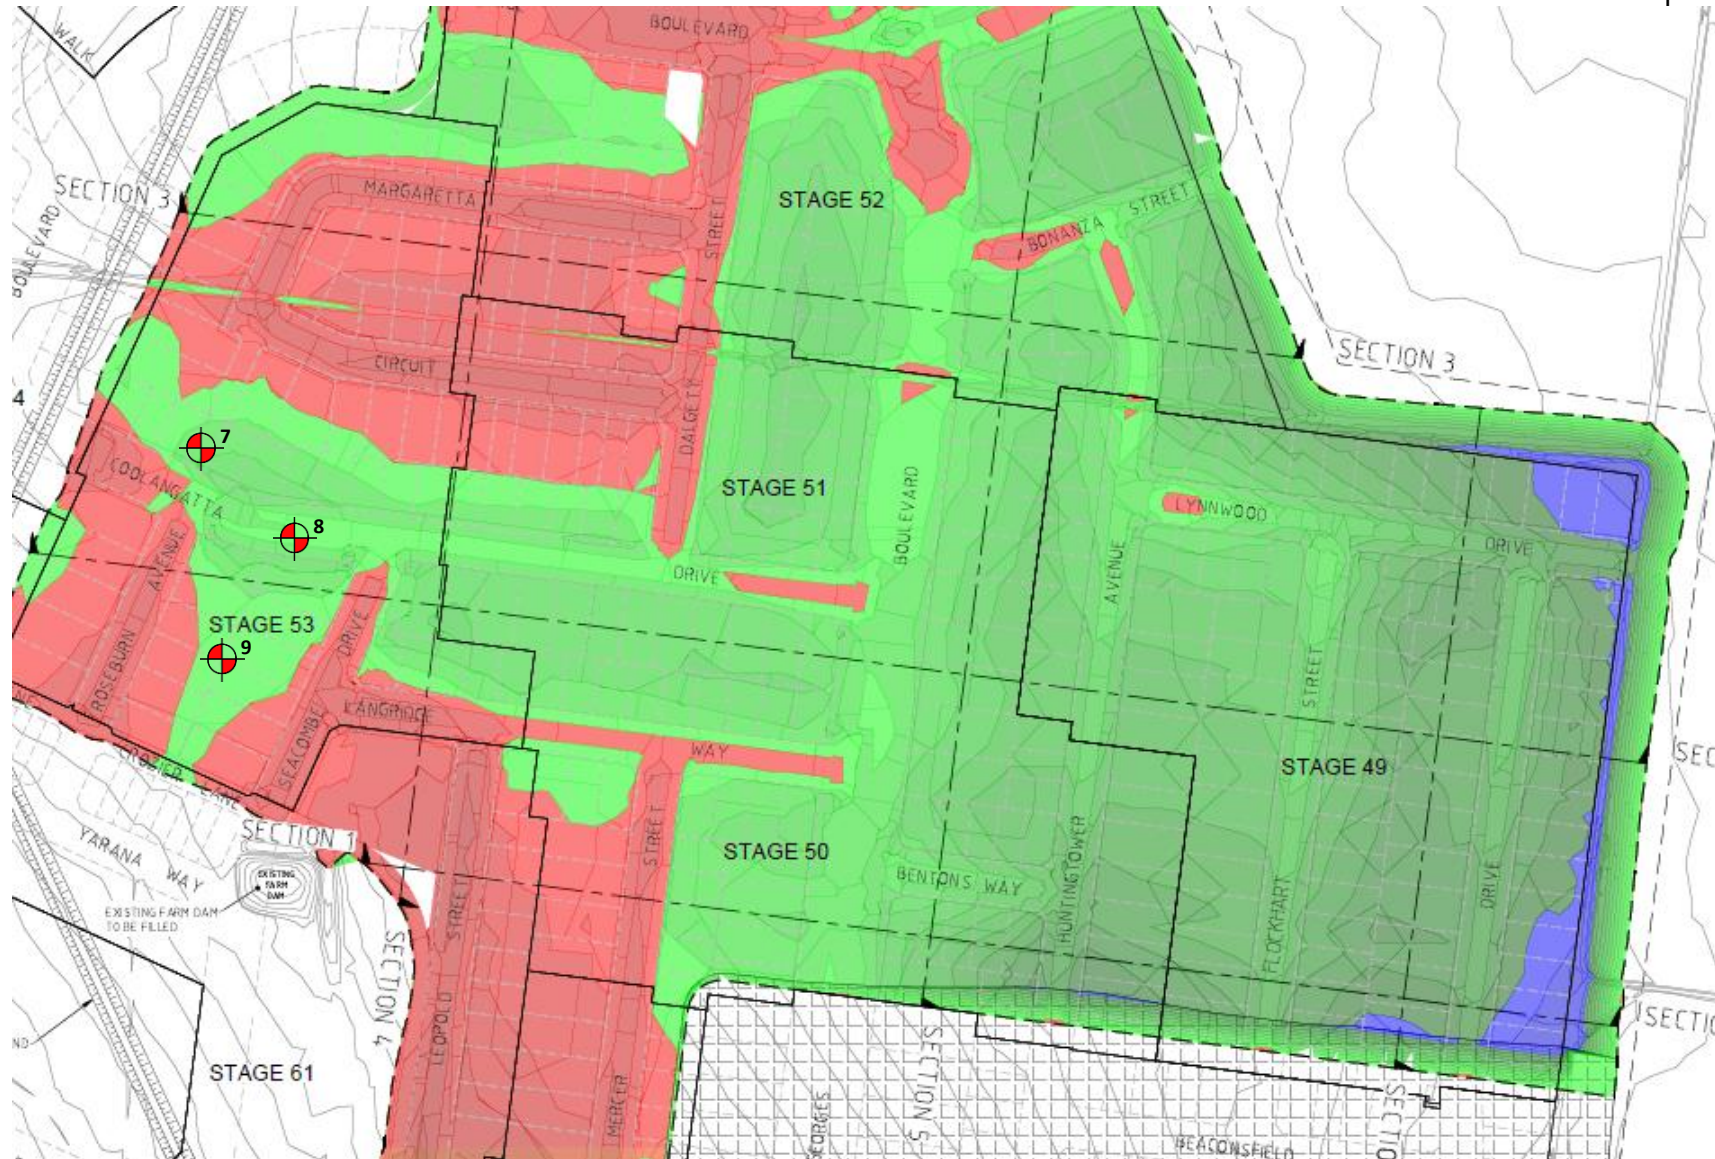
Test Location

PROJECT: Merrifield Estate – Stage 53 (Level 1)	CLIENT: BMD Urban	DATE: 10/01/2023
