# Merrifield Living – Stage 79, Mickleham

## Level 1 Inspection & Testing Report

Reference: 1120 0557-1

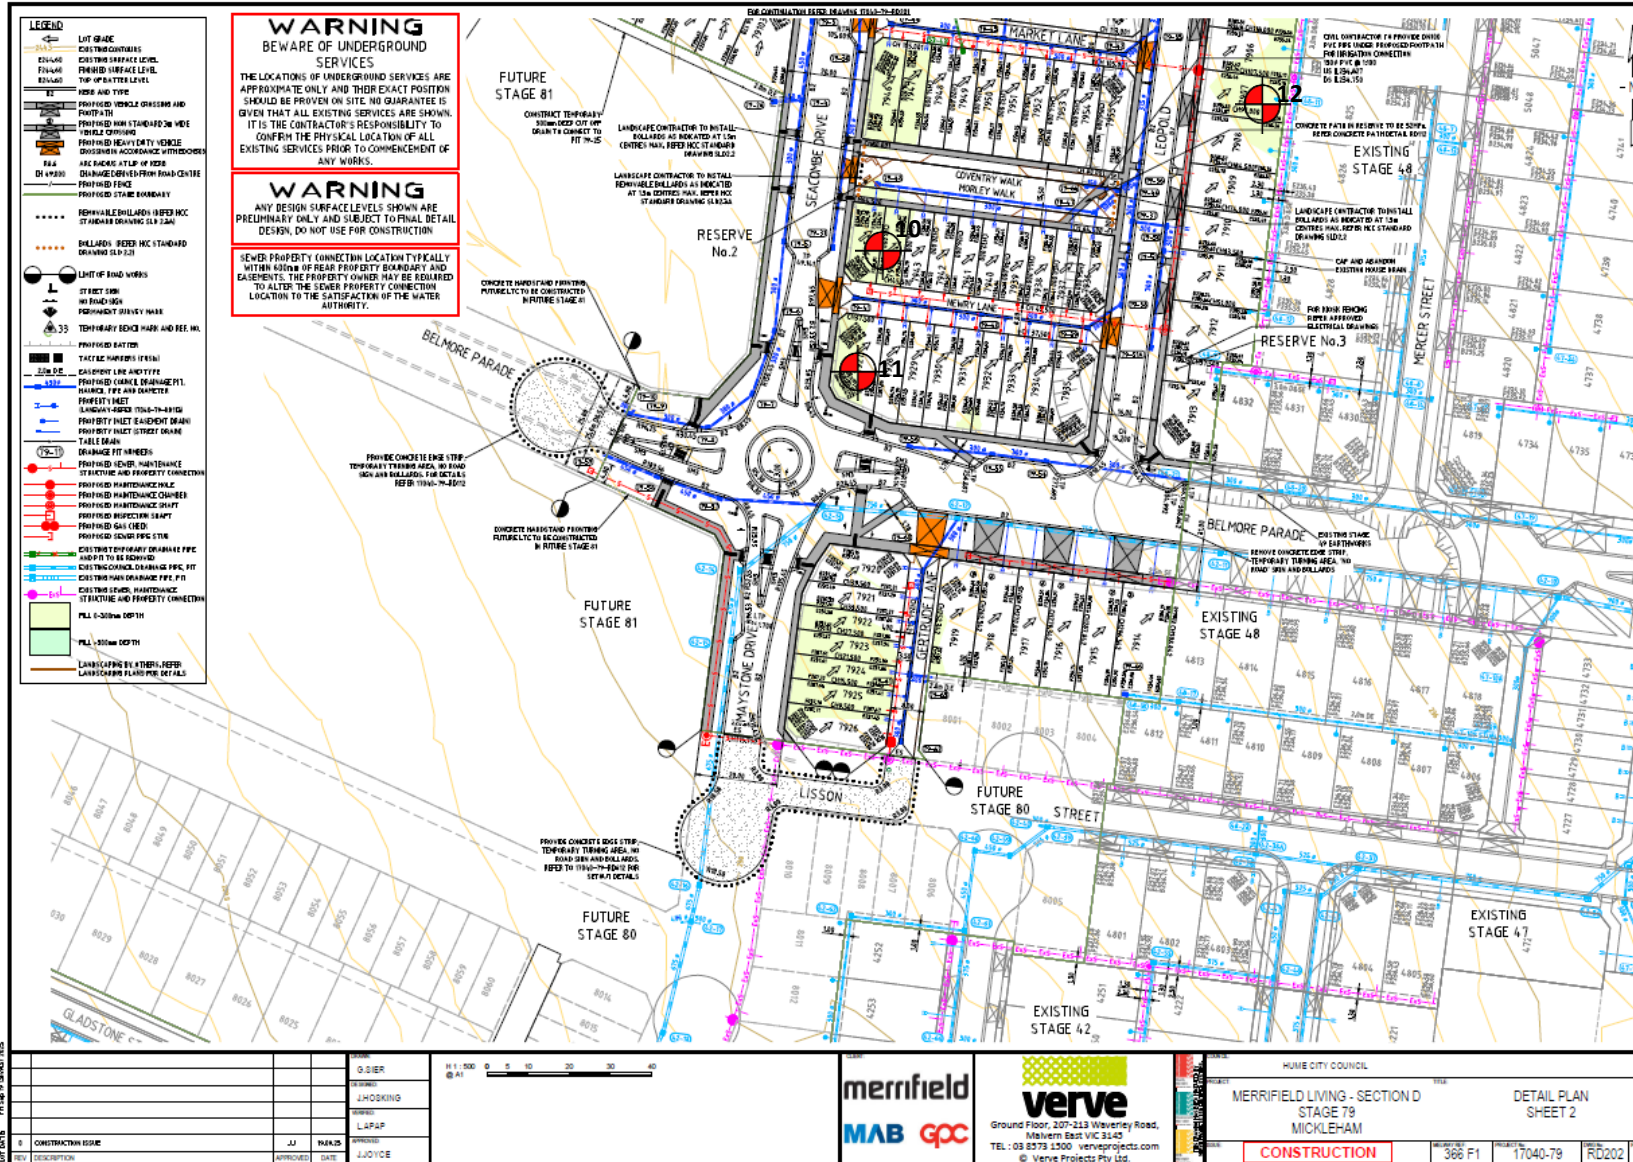
**PROJECT:**  
Merrifield Living – Stage 79 (Level 1)

Test Location	Refer to Plan	Refer to Plan	Refer to Plan			
Level/Layer	FSL	FSL	FSL			
Layer Thickness	mm 200	mm 200	mm 200			
Test Depth	mm 175	mm 175	mm 175			
Field Wet Density	t/m <sup>3</sup> 1.99	t/m <sup>3</sup> 1.99	t/m <sup>3</sup> 1.95			
Field Moisture Content	% 20.8	% 21.6	% 22.2			
Material:	Site Derived Clay	Site Derived Clay	Site Derived Clay

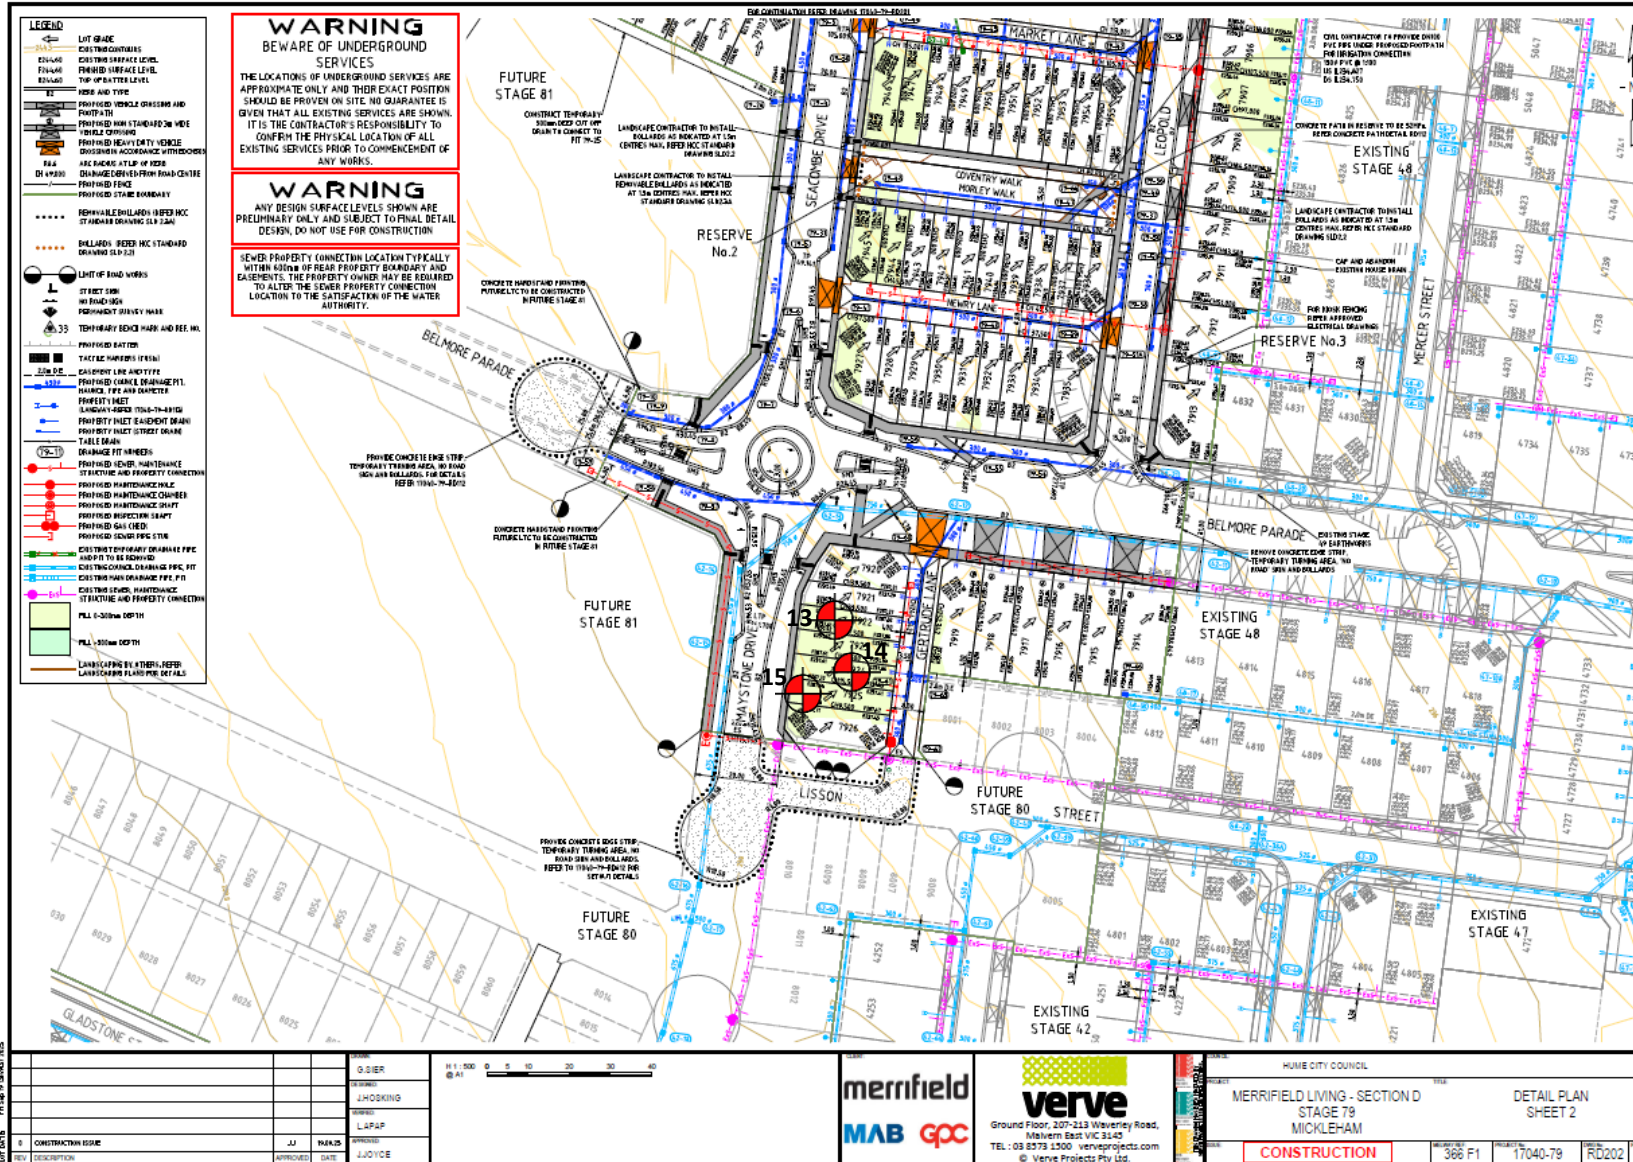
Test Location

PROJECT:  
Merrifield Living – Stage 79 (Level 1)
